Design of a Vibration Sensor Based Train Arrival Detection System to Prevent Elephant-Train Accidents in Sri Lanka

Nuwantha. D. KULARATHNA¹, Sisaara PERERA²

(1. *Institute of Engineers Sri Lanka College of Engineering;*

2. *Department of Electrical and Computer Engineering, The Open University of Sri Lanka*)

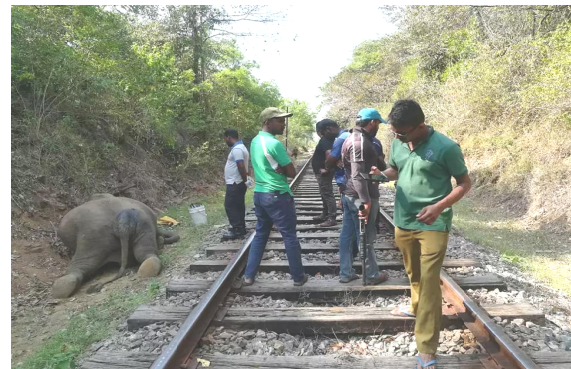
Usually the elephants face fatal collisions as they get trapped between the shrubbery and steep embankment on either side of the track. During the recently reported accident, one elephant was killed and two others were badly injured in Anuradhapura district, which is about 160km (100 miles) away from north of the capital Colombo. According to the senses report of CGR, the train's engine was derailed during the collision and the deceased elephant is shown in the Fig.1, yet none of the 500 passengers was hurt.

Fig.1 Death of Elephant due to Train Collision in Anuradhapura Railway Line

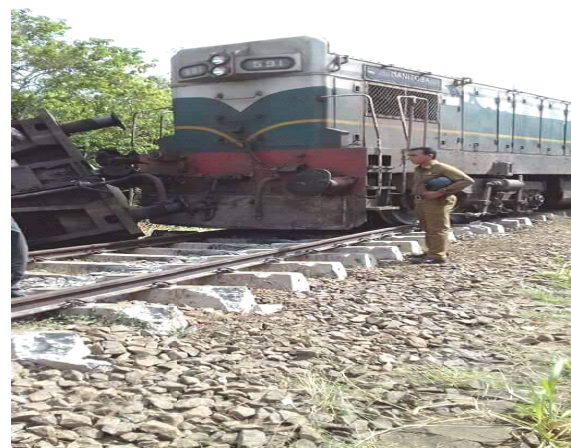
The other recent accident was reported in 18th September 2018. The locomotive was EMD G12 power set, which was made in 1956 by the general Motor Diesel Company (Canada). The accident was happened due to the high speed of the train in a hill area and the damaged locomotive is shown in the Fig.2 and the deceased elephant in Fig.3 respectively.

Fig.2 18-09-2018 Collision and the Derailed Locomotive

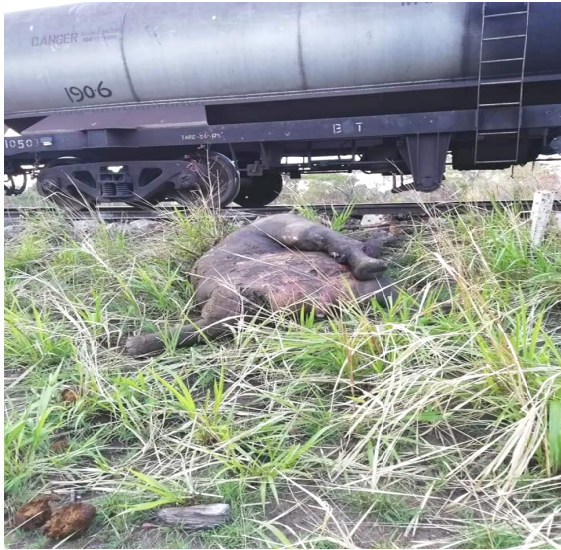
Fig.3 18-09-2018 Collision-deceased Elephant

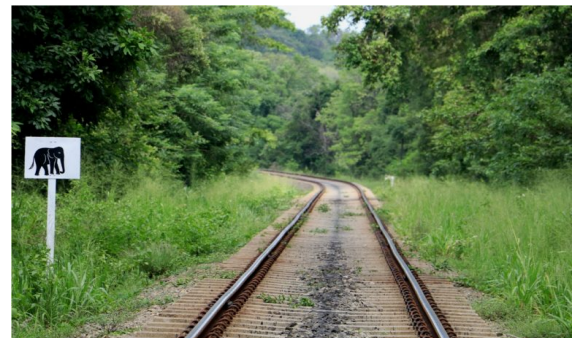
The following table 2 shows the approved speed limits for the locomotives in the elephant crossing points, which is further illustrated in Fig.7.

Fig.7 Elephant Crossing Point in Manampitiya

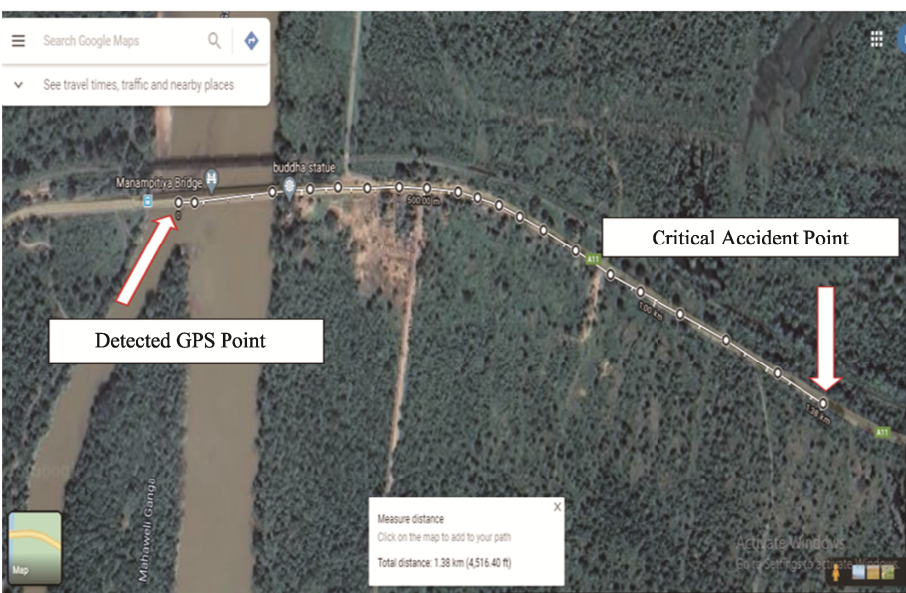
The testings were carried out within the railway stations from the *Polonnaruwa* to *Manampitiya*, where the exact location of the collision point was identified as 7.913562, 81.088902 in Google maps as shown in the Fig.10. The observed results in other GPS coordinates are also tabulated in the following table 3. It has been observed that the, 92.8s time is fair enough time interval for an elephant to safely move away from the track.

Fig.10 A typical Collision Point in a Google Map
